Pahrump Community Library District Lighting Retrofit – RFP # 2022-PCLD-01/PWP NY-2022-391

9-29-2022

Re: Electrical code violations discovered at Pahrump Library, 701 E. East Street Pahrump, NV
Industrial Light and Power, LLC Electrical Permit #BS-22-1536

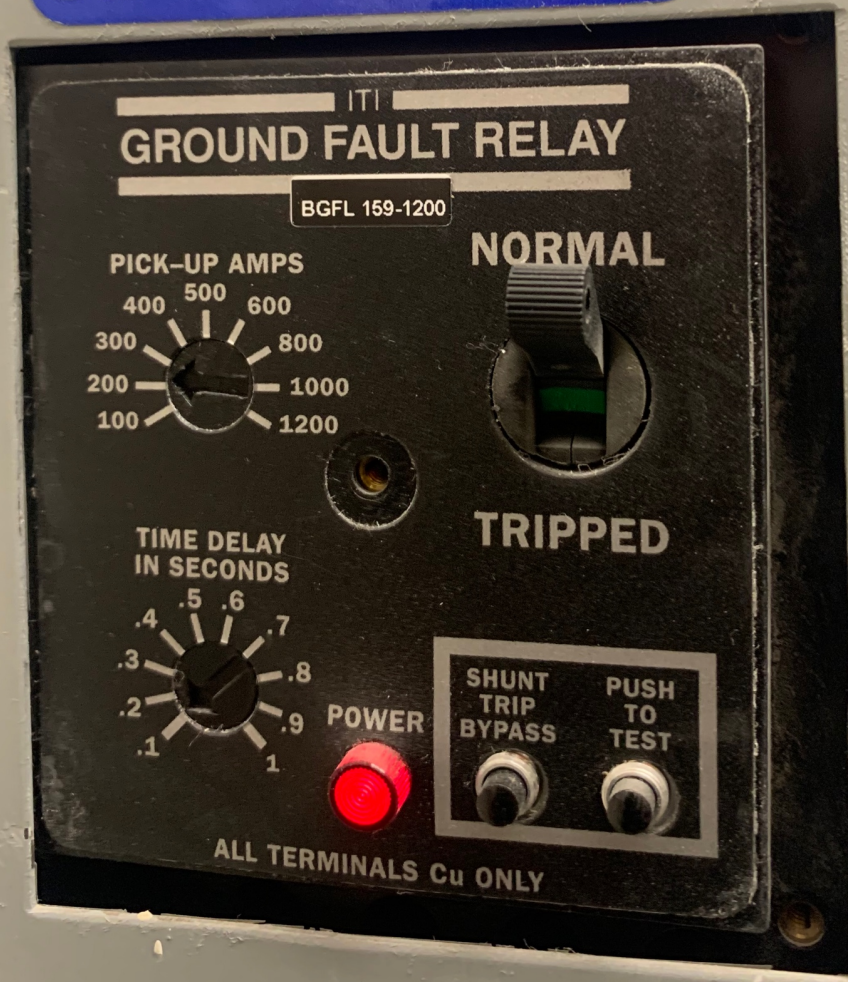
-Multiple instances when working on the existing fixtures, as soon as the fixture wiring box was opened an improperly installed bare conductor within the fixture shorted to ground (luckily ILP's employees are professional experienced electricians and are safety conscious so nobody was injured) however this event caused the 1200 amp main breaker for the building to trip its GFCI Ground Fault Relay, briefly causing power in the entire building to go out on 9/16/2022 and again on 9/27/2022. It was also found that the installed model BGFL 159-1200 GFCI Ground Fault Relay in the facility main switchgear was last inspected on 11-22-2000 (likely during the original installation) with a re-test due per the attached inspection sticker of 11-2003. There is no evidence that this GFCI Ground Fault Relay has ever been retested nor that the main switchgear or panelboards have been inspected per manufacturers requirements. (See Attached photo.)

NFPA 70E requires all electrical equipment to be inspected and mechanically tested per the manufacturer's recommendations, which is every three years. Additionally, NFPA requires that at a minimum you have arc flash warning labels installed on all electrical panels and your panels are also missing these minimally required warning labels. (At the main switchgear and then three additional panels within the building). We also suggest having a third-party arc flash hazard analysis and coordination study performed at the facility as well to be in full compliance with the NFPA and NEC as it seems from the visible labeling that your electrical power distribution system has not been fully tested since it was installed in 2000.

GROUND FAULT SYSTEM
PERFORMANCE TEST

☐ CALIBRATED ☒ TESTED

REFERENCE NO. 2302814

DATE 11-22-00 SETTINGS:

RETEST 11-2003 200 AMPS

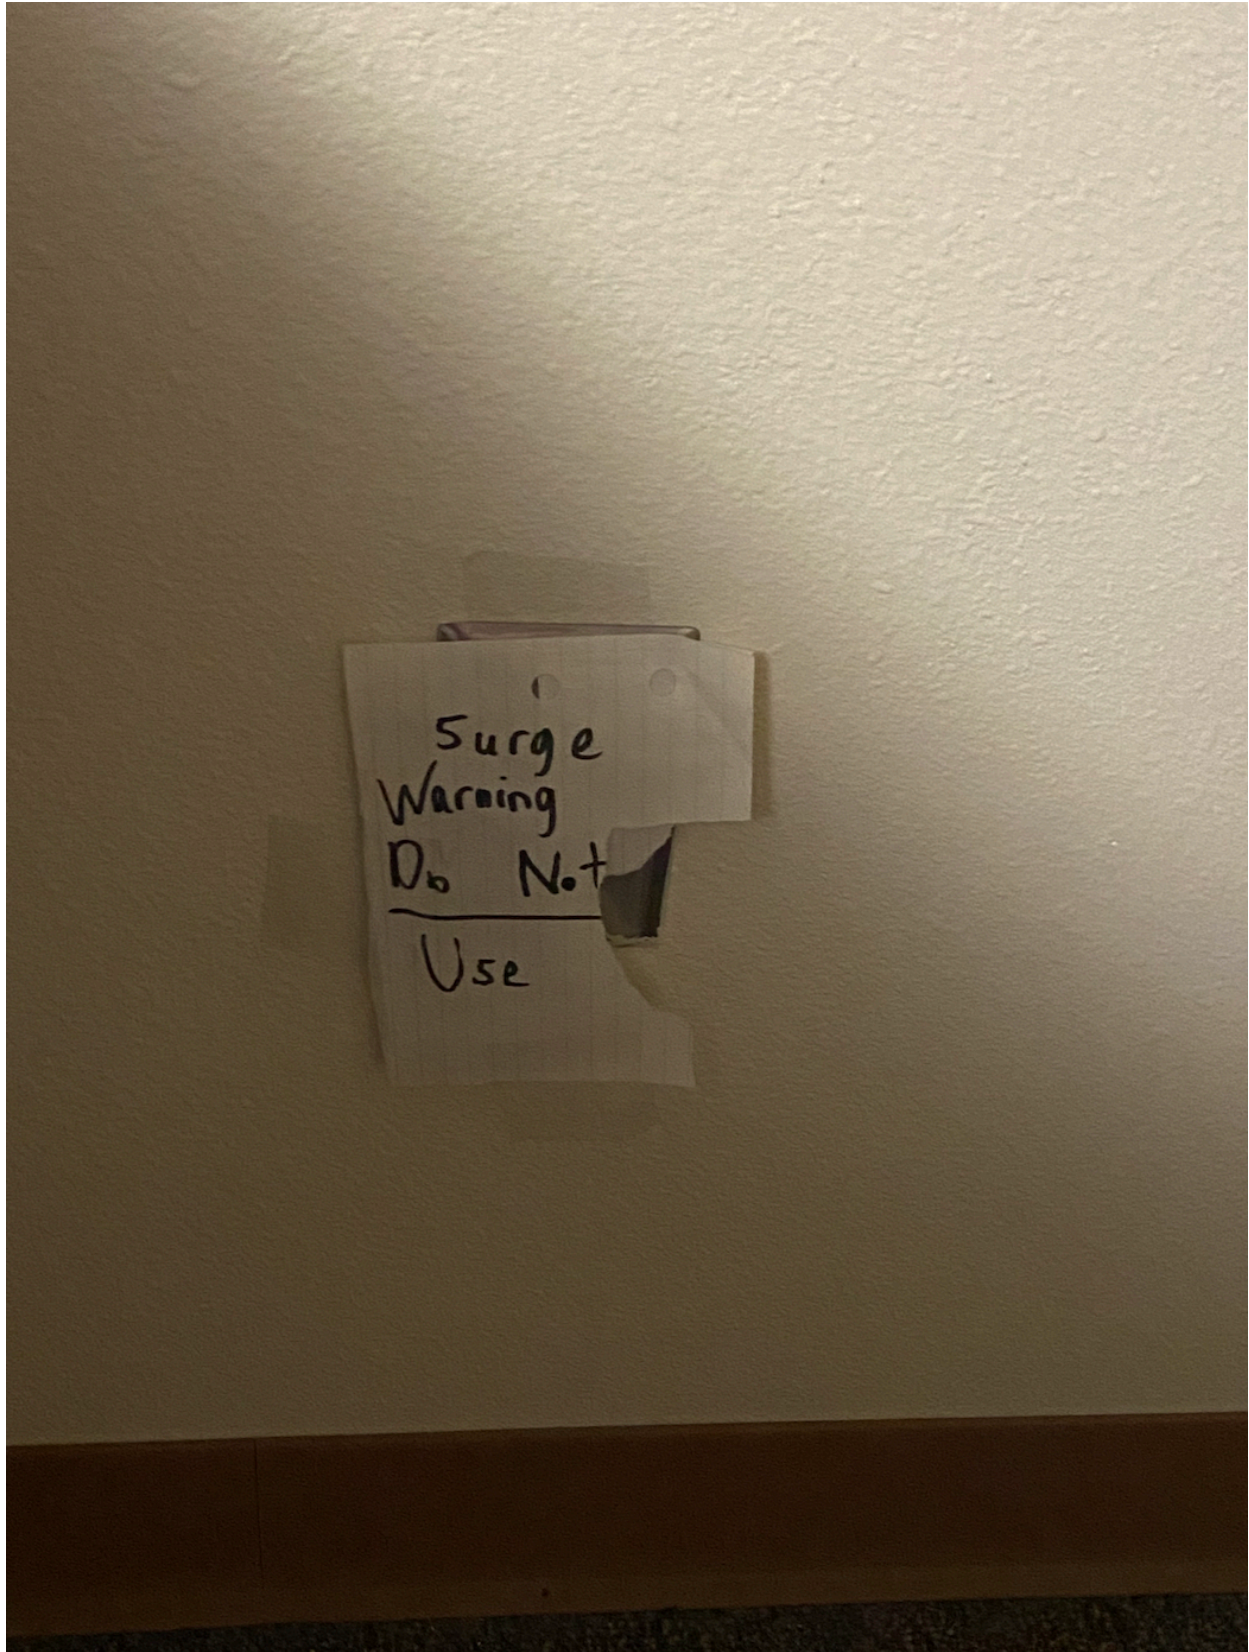
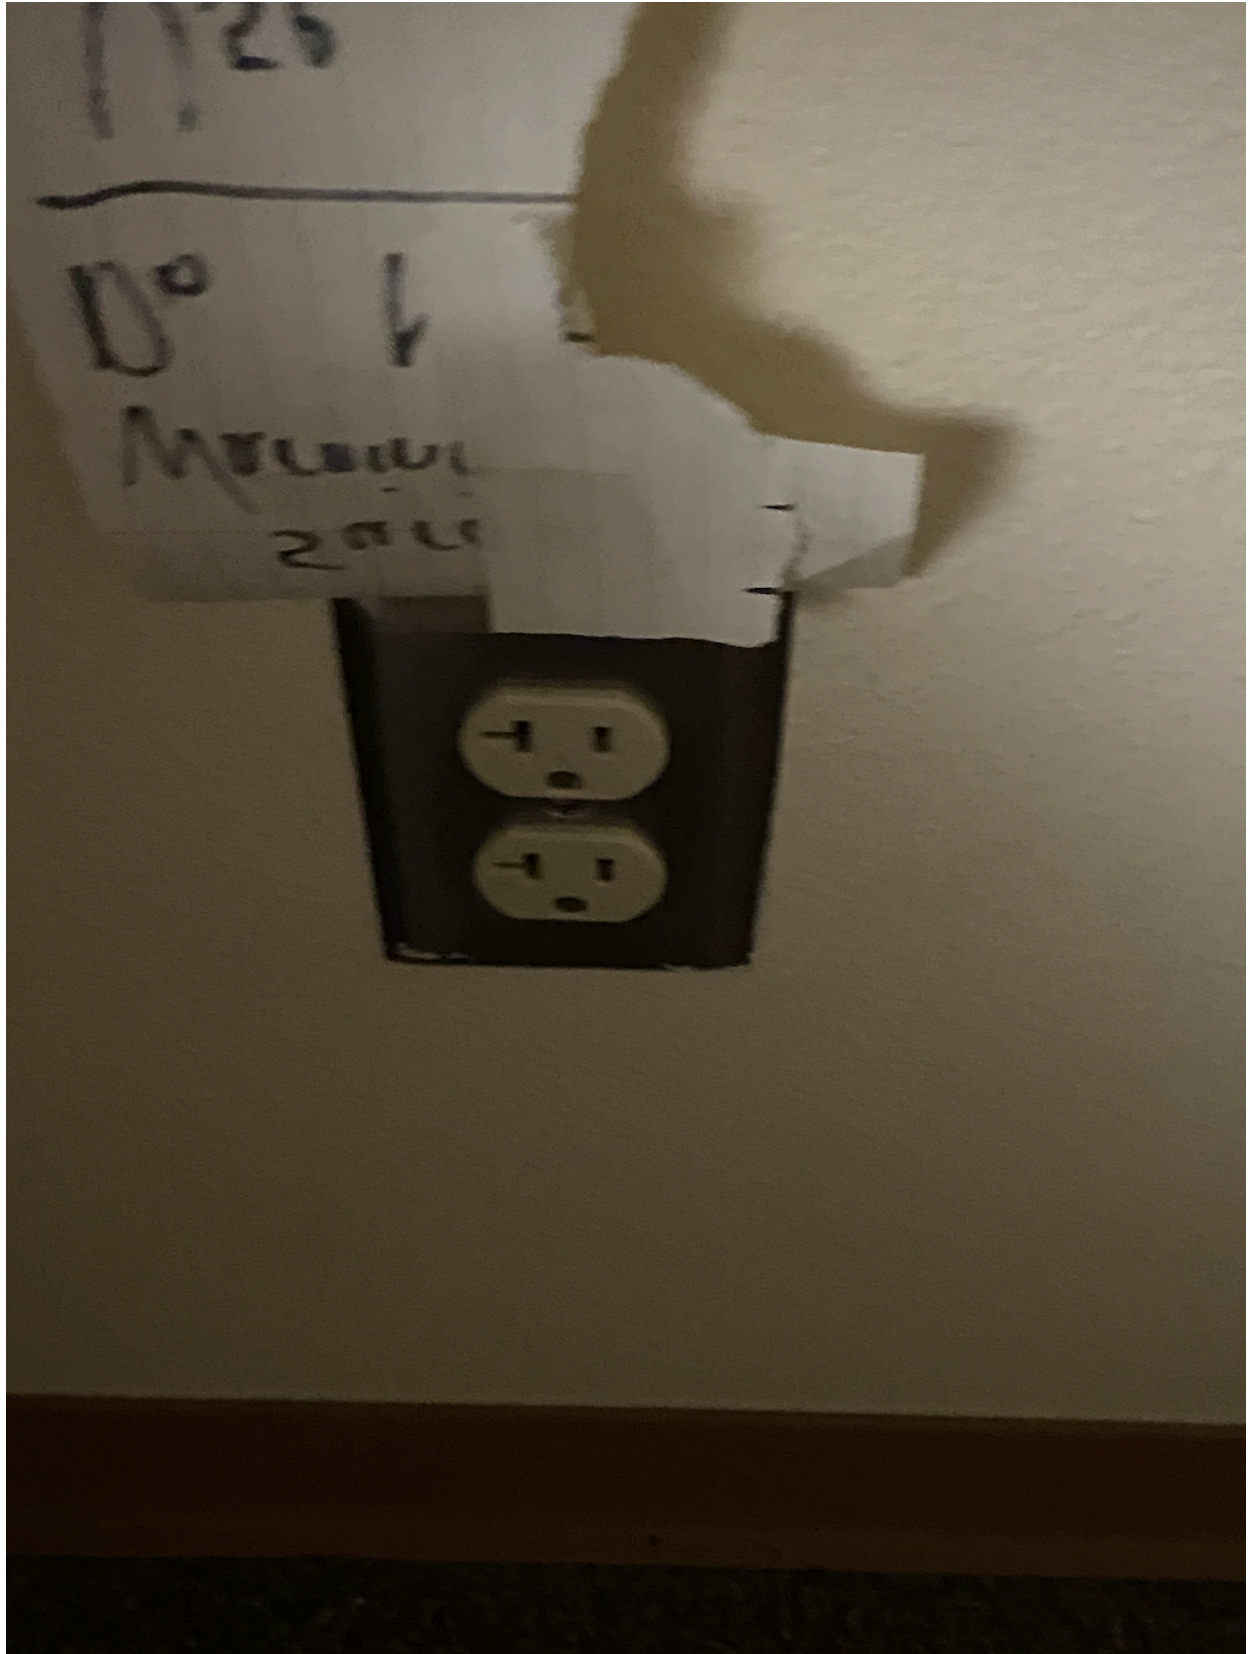
There was also an existing receptacle located to the left of the computer lab in the main library with a piece of flammable paper taped over which had written on it by library staff "Surge Warning- Do Not Use". (See Attached Photos.)

Due to the potential life safety and fire hazards associated with this diagnosis previously made and noted on the device by some unknown person regarding a "surge issue" ILP has advised the Library Board Chairman that we need to connect circuit testing equipment and perform a 7 day data logger test on that branch circuit and to provide a testing report to see if there is in fact a "surge issue" by recording electrical measurements 24/7 for a 7 day period and to review to see if there are any clear signs of surges/swells present in that recorded data range on circuit L3/20.
